National Transportation Safety Board

RRD22LR001

MATERIALS LABORATORY

Specialist's Factual Report - Supplemental 22-032B

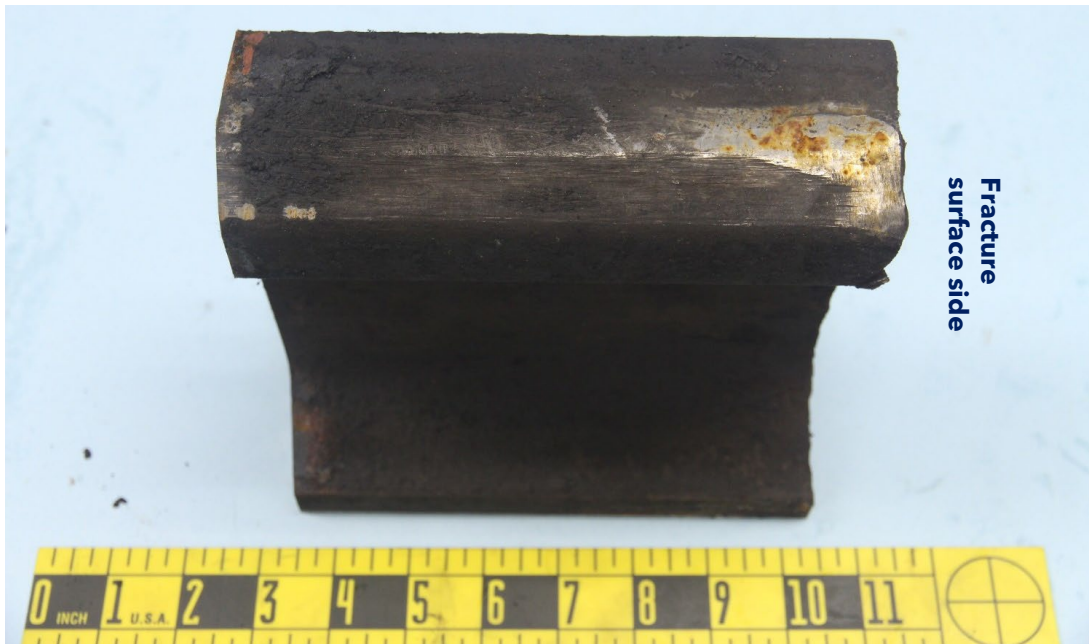
Figure 1 shows the section of the guard rail from the side at the outside or field corner. The majority of the surfaces were covered in a black-colored, sticky substance, consistent with material accumulated from service in a rail tunnel.

In the figure, the fracture surface faces towards the right. On the field corner near the fracture was a more reflective area, exhibiting some localized brown-colored spots. The reflective area was oriented parallel to the running direction of the rail head, with streak marks oriented along the rail direction. This area was consistent with an impact with a metallic component, after the dark material accumulation. The brown spots were consistent with oxidation from reactions with water after the impact or sliding event.

Figure 1. View of the sectioned mount remnant and fractured stud, as received.

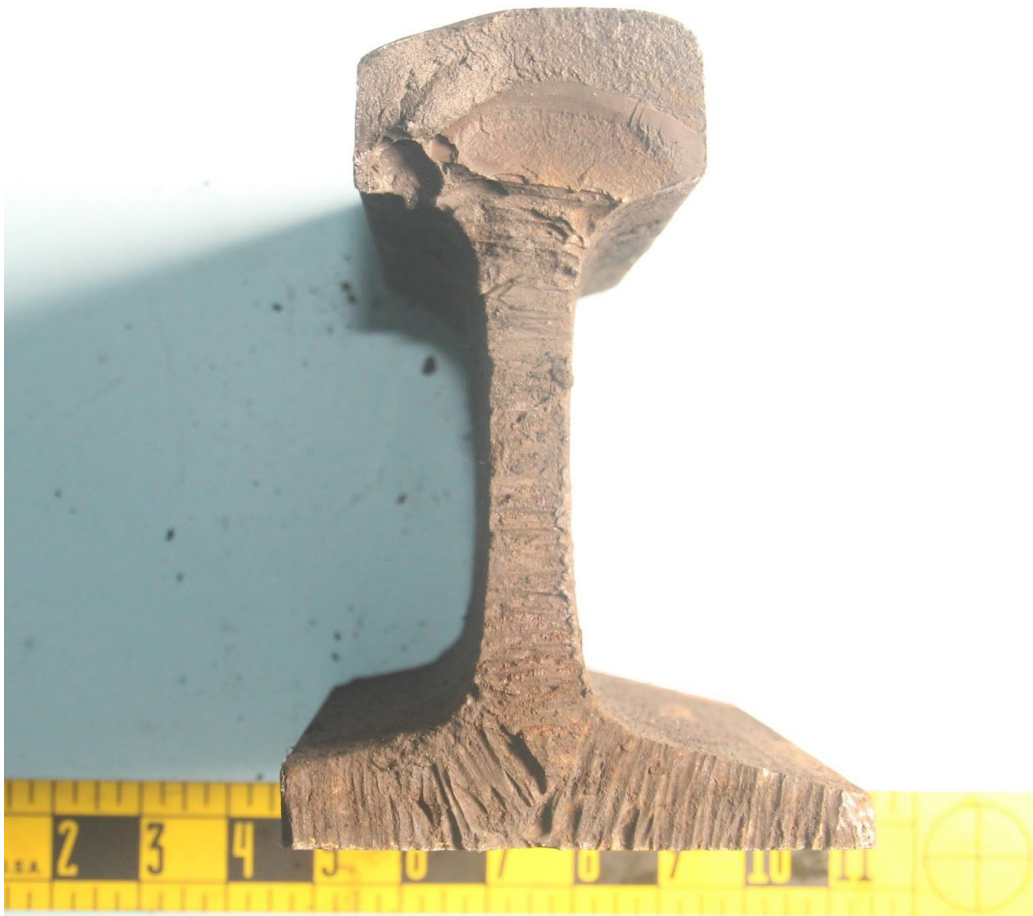
Figure 2 shows the fracture surface of the restraining rail, as received. This figure was overexposed in oblique lighting to demonstrate the dark-colored features on the surface. Most of the surface exhibited elongated deep undulating features, located along the base and web regions. These marks were mostly oriented perpendicular to the material cross section, with some angled orientation at the web/base transition. Closer examination of these regions showed smoothed and rounded features, consistent with melting and resolidification of metal alloys. These regions were consistent with having been torch cut.

Figure 2. View of the fracture surface of the guard rail section, as received (overexposed to show the darker fracture features).

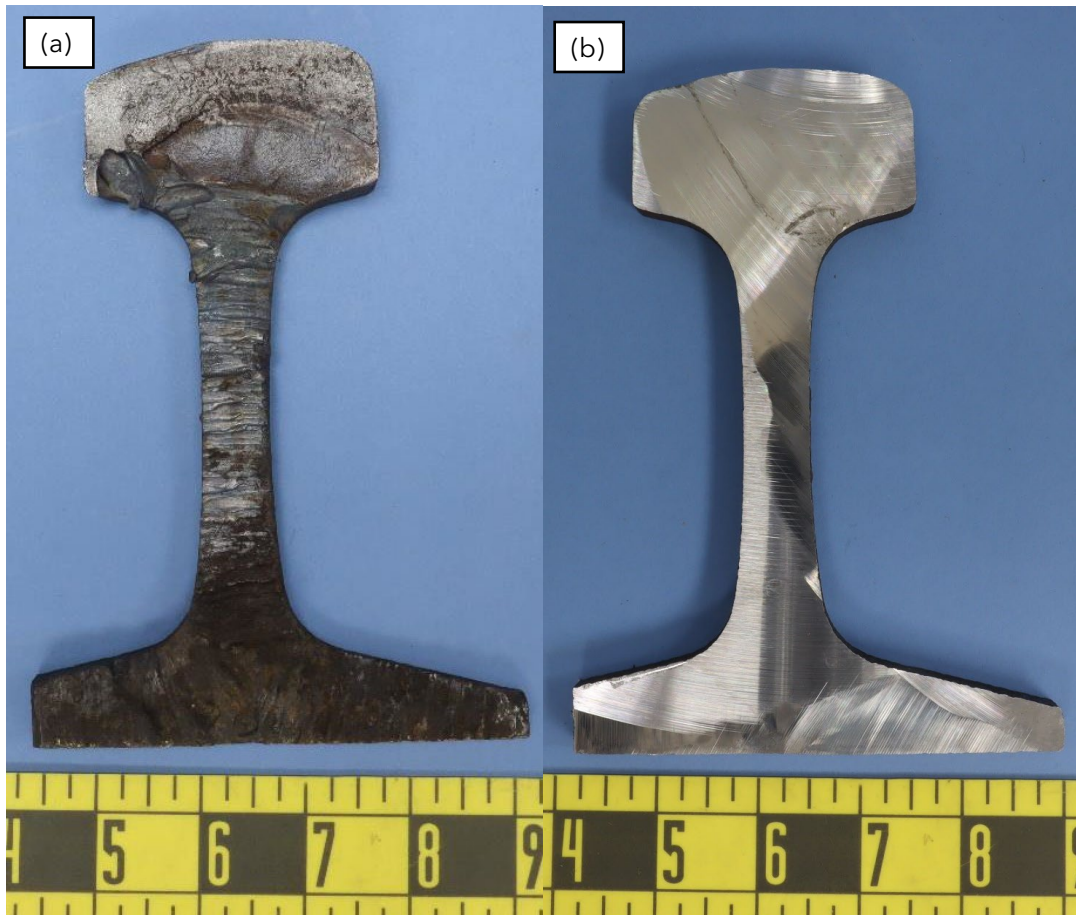
The fracture surface was sectioned from the rail segment, along with another adjacent cross section, as illustrated in Figure 3. The fracture surface was cleaned in an ultrasonic bath of acetone, which removed most of the dark surface contamination, indicating it had been consistent with organic material. Figure 3a demonstrates the bluish-gray and dull gray colors of the torch cut region along the web, typical of steels exposed to elevated temperatures. The cross section in Figure 3b shows the change in the head geometry on the field (upper left) corner. This was consistent with material deformed and flowing over the fracture surface (upper left in Figure 3a) and the reflective area absent dark contamination on the rail head surface in Figure 1.

Figure 3. View of (a) the sectioned and cleaned fracture surface of the guard rail, contrasted with (b) a cross section through the rail, showing the rail profile.

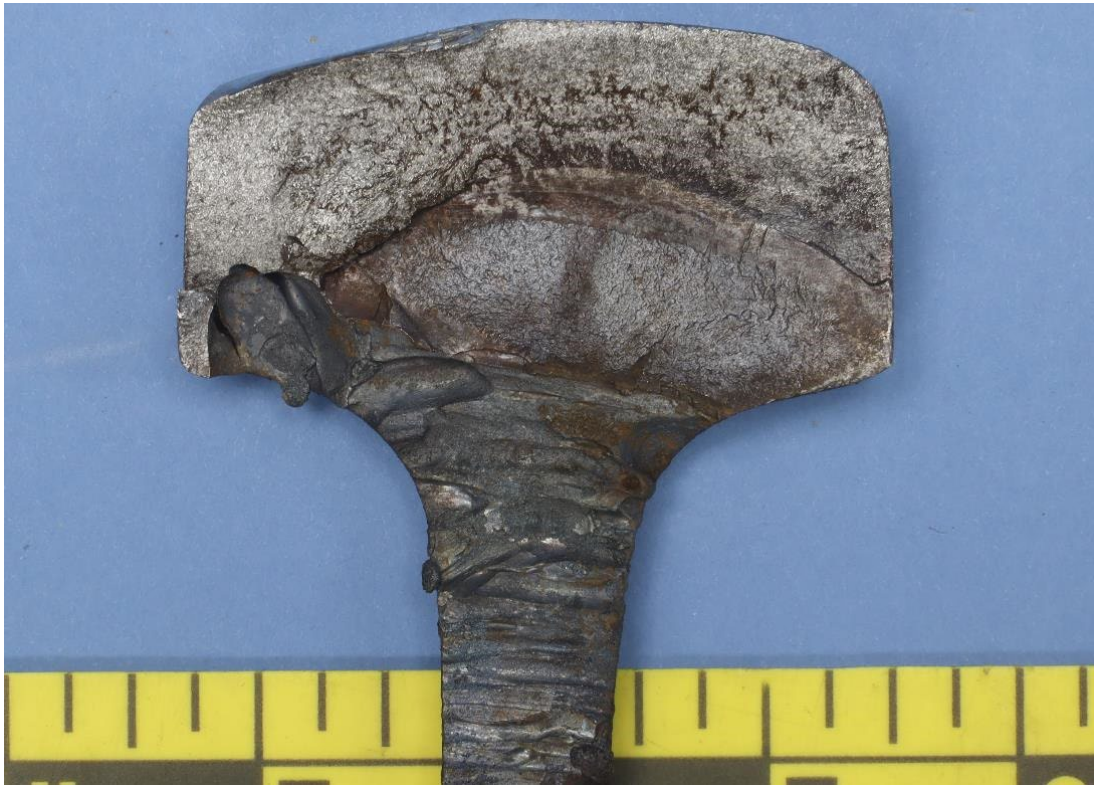
The head area of the fracture surface exhibited several different fracture features, distinct from those of the torch cut web and base cross sections. Figure 4 shows a closer view of the head. As shown in this figure, there were alternating bands of rougher and smoother fracture features. The head of the fracture surface was sectioned from the web, and then cleaned in an ultrasonic bath with Evapo-Rust in order to remove surface oxidation.² Figure 5 illustrates the sectioned and cleaned fracture surface head region, annotated to show the different fracture regions. These included two regions of crack propagation, consistent with fatigue, and two regions of overstress fracture features. The details of these fracture modes are elaborated below.

Figure 4. Closer view of the restraining rail head fracture surface, after initial cleaning.

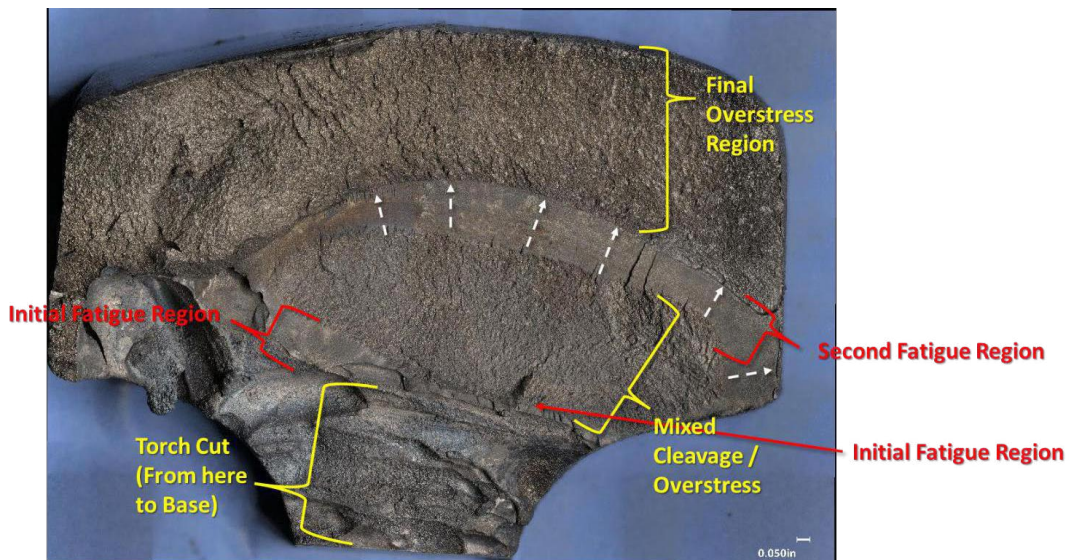
The fracture features of the rail head, annotated in Figure 5, were consistent with the rail having been torch cut prior to any crack initiation and propagation in the head. The web and base exhibited features consistent with much of the rail cross section having been torch cut. There was an initial fatigue crack region, which had initiated at multiple sites along the edge of the torch cut gap in the web. A fatigue crack propagated for a small (0.5-1.0 mm) depth before a large overstress jump occurred. This did not completely fracture the rest of the rail head, and a second band of fatigue cracks initiated at another series multiple sites. The remainder of the rail head fractured in overstress from a final stress input.

Figure 5. The cleaned head fracture surface, annotated to show various regions.

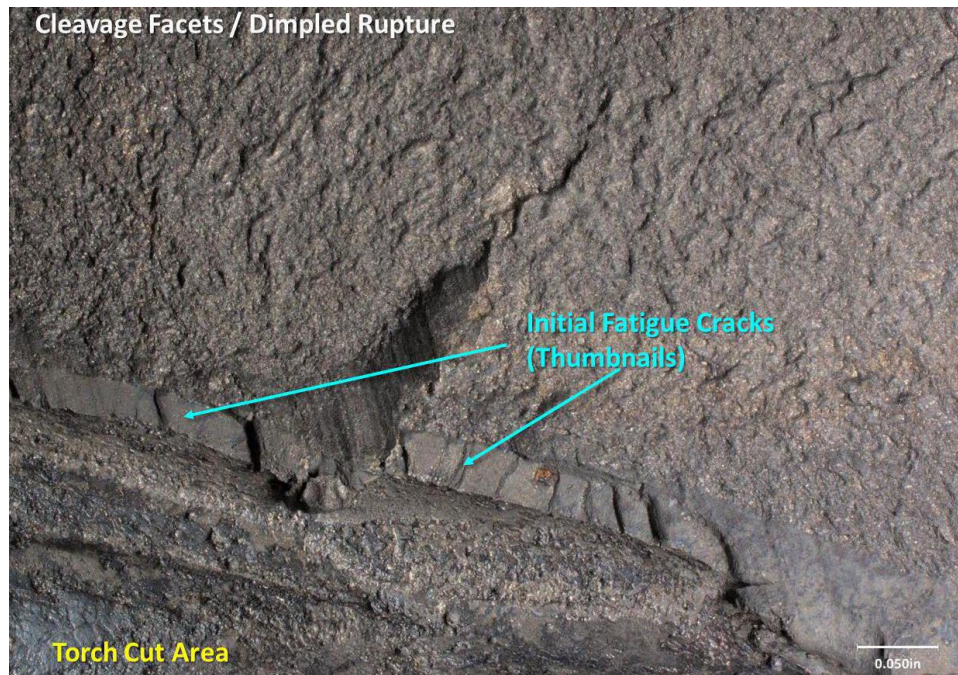
Figure 6 shows an area of the head fracture surface adjacent to the torch cut region of the web. This area exhibited a relatively flat band, consistent with progressive crack propagation later determined to be fatigue. This region exhibited multiple thumbnail cracks, separated by ratchet marks, indicative of multiple crack initiation sites.

Figure 6. The initial fatigue thumbnail cracks near the torch cut web section.

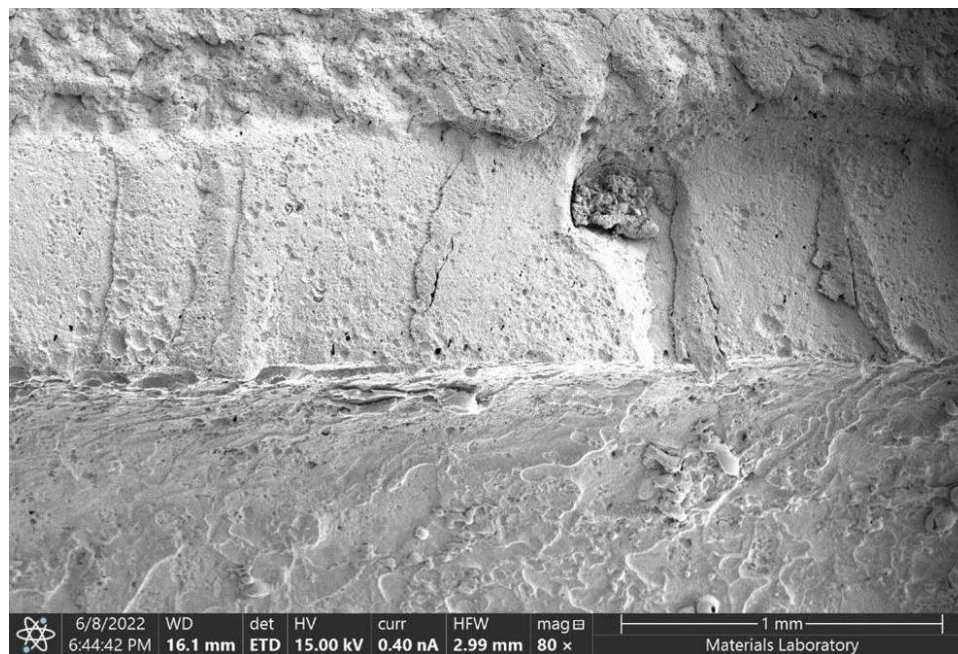
The area adjacent to the torch cut material was examined with a scanning electron microscope (SEM), as shown in Figure 7. This figure shows the multiple thumbnail-shaped fatigue cracks, exhibiting crack arrest marks concave upward, consistent with propagation from the torch cut regions into the rail head. Figure 8 is an annotated version of Figure 7, showing the general crack growth direction of the small thumbnail cracks. This region showed crack propagation for approximately 0.5 to 1.0 mm (0.02 – 0.04 in).

Figure 7. SE micrograph of fatigue cracks near the torch cut web.

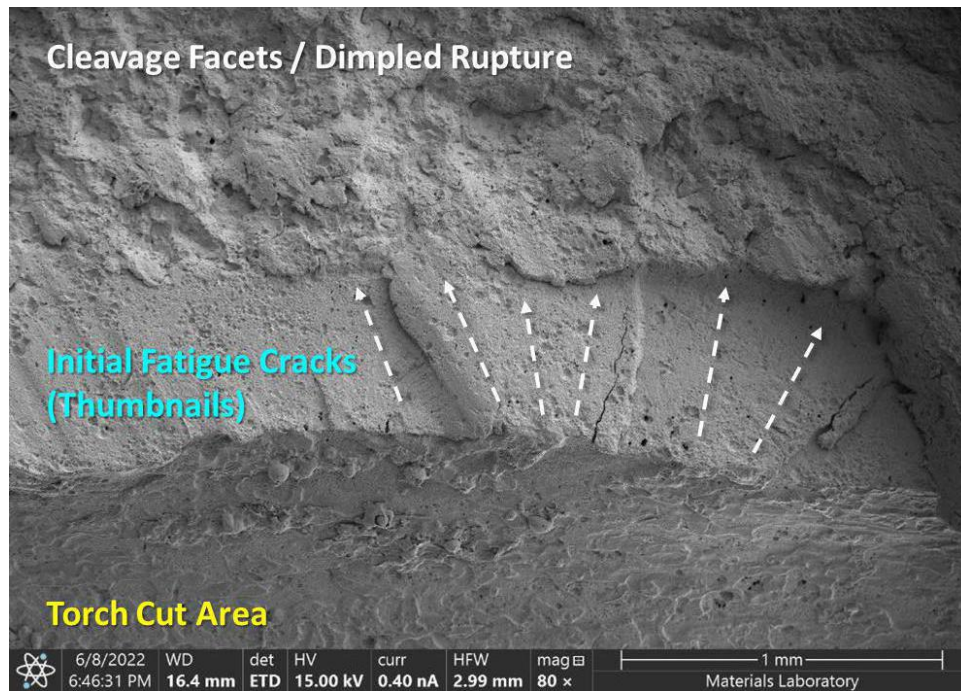
Figure 8. SE micrograph of the initial fatigue region near the torch cut, annotated.

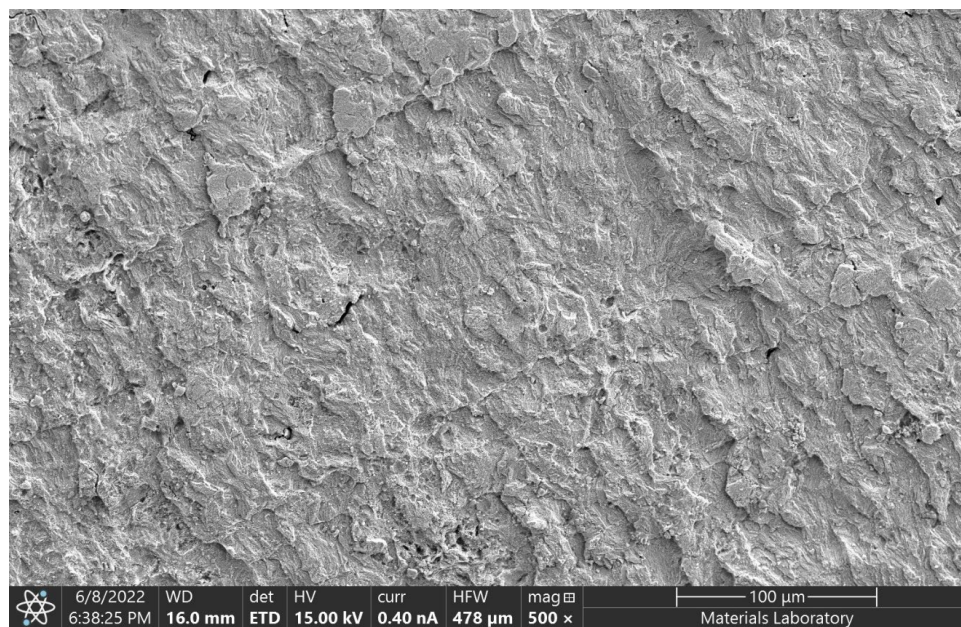
As shown in Figure 9, these thumbnail cracks exhibited fatigue striations, consistent with fatigue crack propagation. Figure 10 shows a closer view of the overstress region outside of the crack propagation region, further upward in the rail head. This area exhibited cleavage facets and dimpled rupture, consistent with overstress fracture in hardened metal alloys.

Figure 9. SE micrograph of fatigue striations on the initial fatigue region of the rail fracture surface.

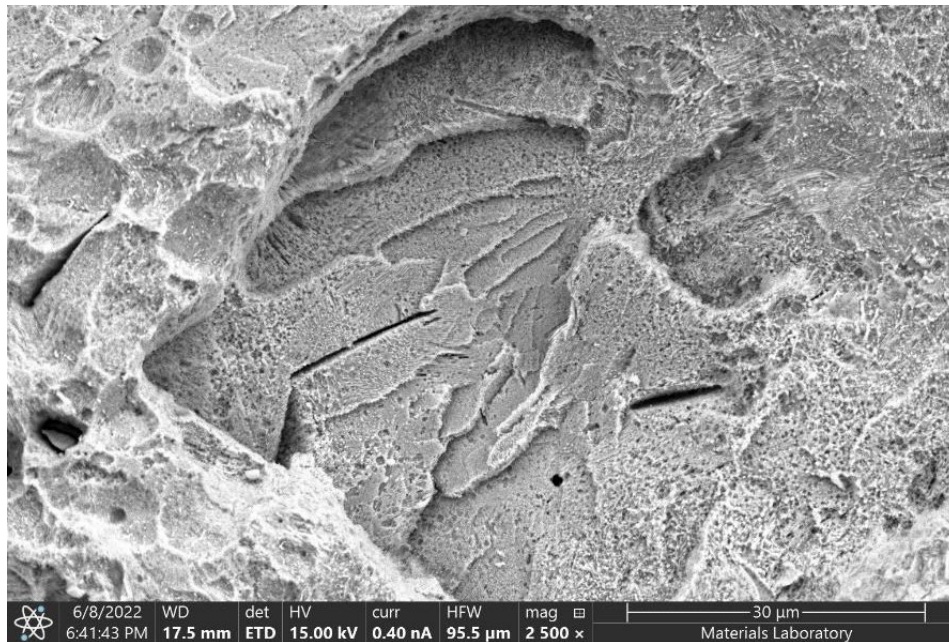
Figure 10. SE micrograph of a typical cleavage facet remnant from Figure 12.

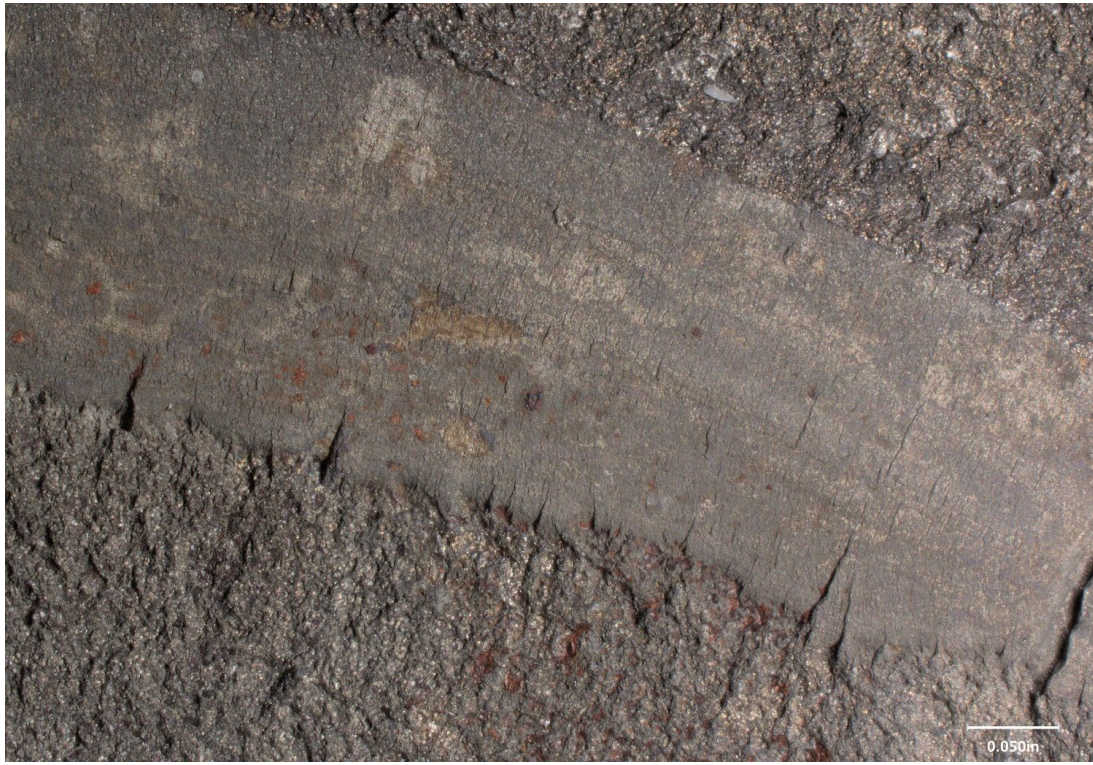
The most visually apparent feature in the head region of the fracture surface is the smoother textured curved band, later determined to be fatigue crack propagation. Figure 11 shows a closer view of this second fatigue region band in the head portion of the rail. This area exhibited crack arrest marks, consistent with crack propagation, and ratchet marks along the lower portions, indicative of smaller cracks coalescing into larger ones. The ratchet marks were located concurrent with pronounced rougher features along the lower (concave) edge of the crack propagation. Like with the initial fatigue region, this area exhibited striations when examined with a SEM.

Figure 11. View of the right side of the intermediate fatigue band region, showing ratchet marks and crack arrest marks.

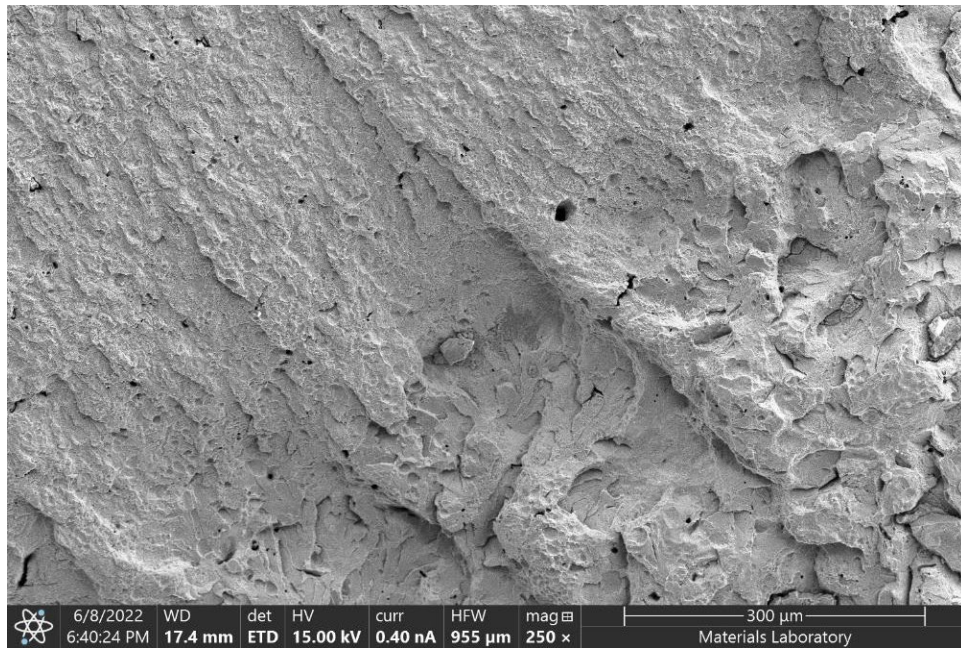
Figure 12 shows the transition from the mixed cleavage overstress region to second fatigue region, shown optically in Figure 11. The area in the upper left of Figure 12 shows the fatigue propagation region, and the lower right shows the mixed cleavage overstress region. Two of the diagonally-oriented ratchet marks we located concurrently with two of the more pronounced protrusions of the overstress regions. The areas in between contained fatigue crack initiation sites.

Figure 12. SE micrograph of the initial transition from overstress to the second fatigue region.

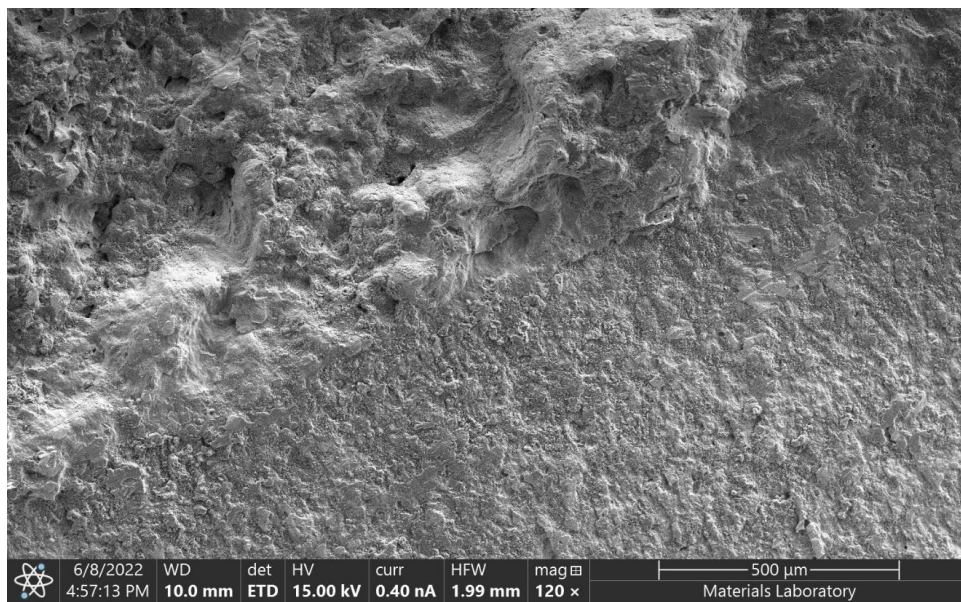
Figure 13 shows the opposite (convex or upper) edge transition of the main crack propagation band, as examined using a SEM. This micrograph was taken prior to cleaning with Evapo-Rust, and shows some of the underlying fatigue striations, but also exhibited a thick enough oxidation layer to create charging effects in the microscope.

Figure 13. SE micrograph of the transition from the second fatigue region to final overstress region of the rail head (before final cleaning).

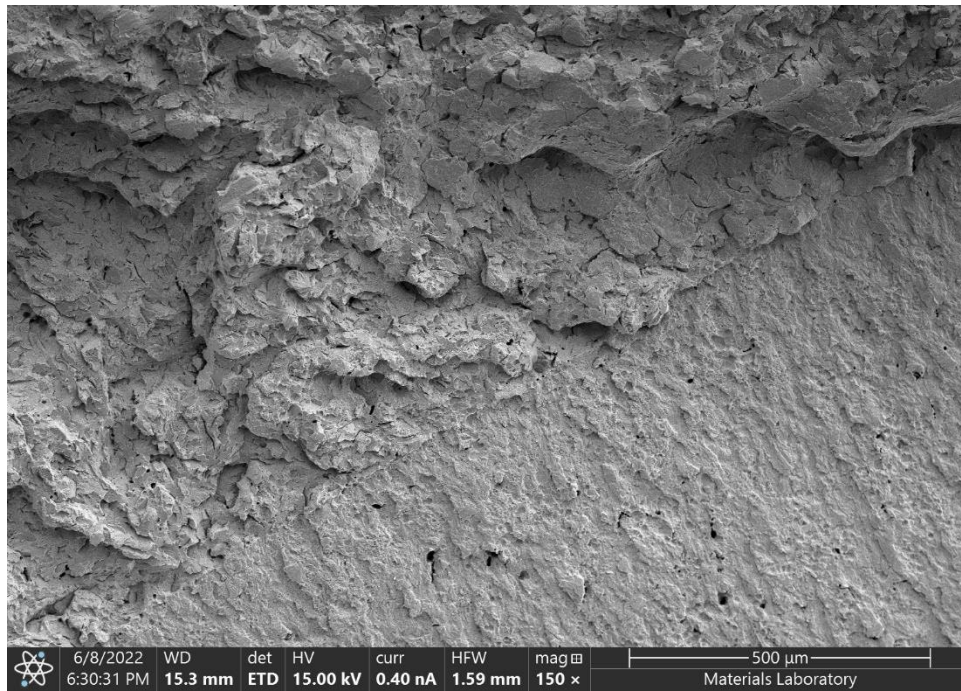
Figure 14 shows the same region, after the final cleaning step. This removed the surface oxidation, but also removed some of the fracture details at particular magnification ranges. The flatter, smoother region in the lower right was the fatigue

Figure 14. SE micrograph of the region in Figure 13, after cleaning.

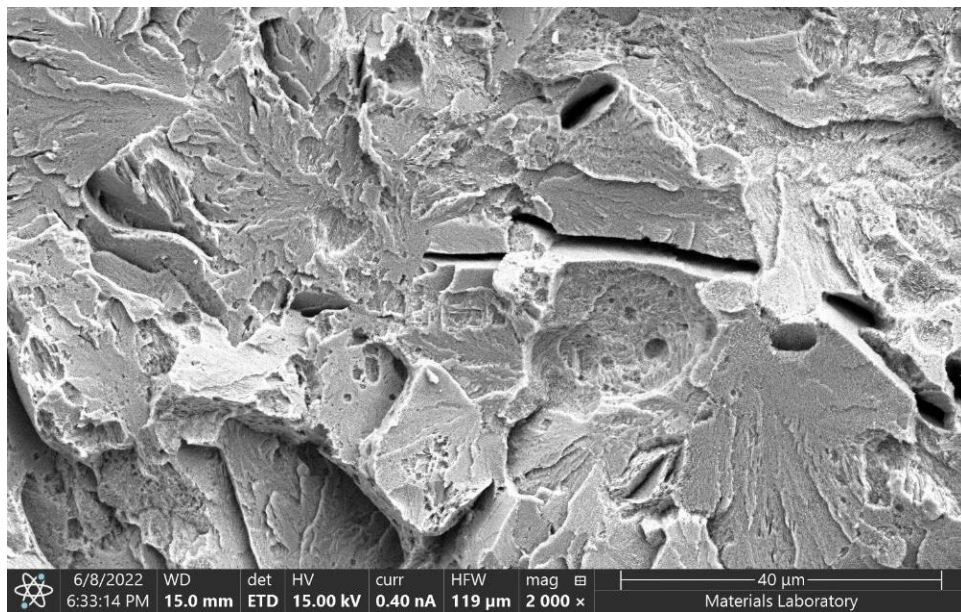
crack propagation region, exhibiting crack arrest marks and fatigue striations. The more tortuous region in the upper left of Figure 14 was the subsequent overstress region. A closer view of this area is shown in Figure 15. This area exhibited cleavage facets and dimpled rupture, consistent with overstress fracture in hardened metal alloys.

Figure 15. SE micrograph of a cleavage facets and dimpled rupture in the final overstress region from Figure 14.
